Manhole Inspection Summary

Manhole # S51EE_017MH

Insp Date: **6/27/08 8:50 AM**

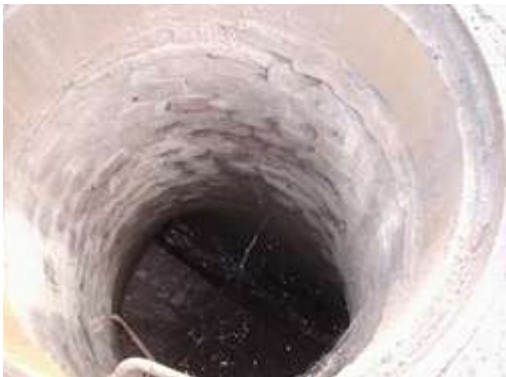
Defect 2

Count: **4** Missing: **2** ☒ **Corroded**

Missing Steps

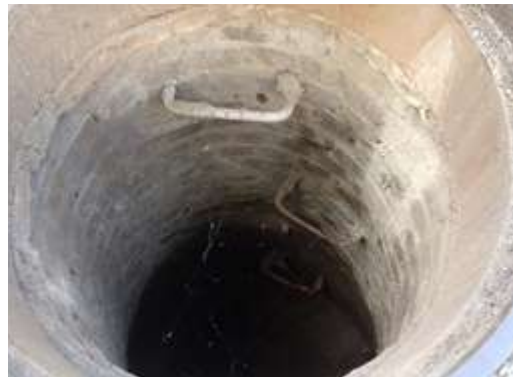
Defect 1

Infiltration: ☐ None ☐ Joint ☐ Cracks ☐ Mortar ☐ Roots ☒ **Wall**

Infiltration

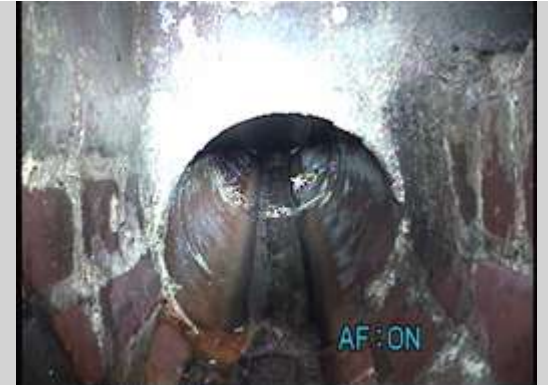
12 O'Clock Outflow

8 in. Circular Gravity Sewer
Pipe Out @ 12 O'Clock

Pipe Height: **8.4** (in.) Rod and Bar (Angled)
Pipe Material: **Clay** ☐ Pipe Lined
Invert Depth: **9.55** (ft.) Flow Characteristics: **Slow**
Deposits: ☒ None ☐ Mud ☐ Sludge ☐ **Debris** ☐ Grease
Silt Depth: (in.) Deposits Extent:
Infiltration: **None** Pipe Seal Cond: **Sound**

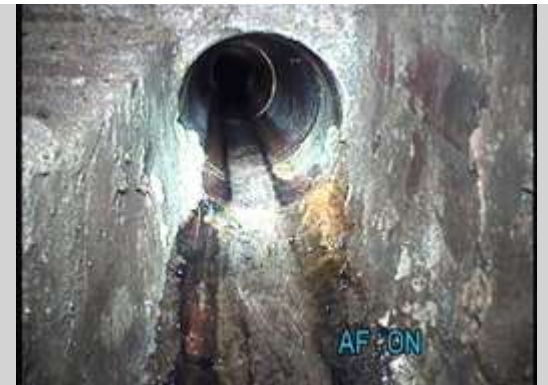
6 O'Clock Inflow

8 in. Circular Gravity Sewer
Pipe In @ 6 O'Clock

Pipe Height: **8.4** (in.) Rod and Bar (Angled)
Pipe Material: **Clay** ☐ Pipe Lined
Invert Depth: **8.65** (ft.) Flow Characteristics: **Slow**
Deposits: ☒ None ☐ Mud ☐ Sludge ☐ **Debris** ☐ Grease
Silt Depth: (in.) Deposits Extent:
Infiltration: **None** Pipe Seal Cond: **Sound**

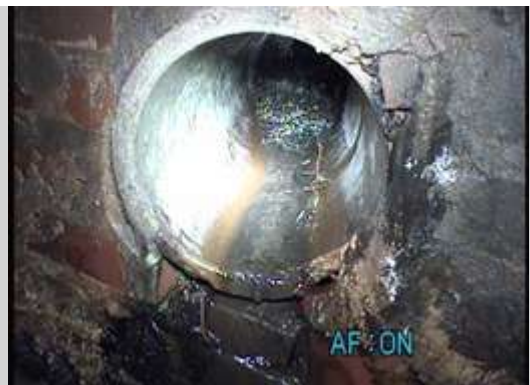
9 O'Clock Inflow

8 in. Circular Gravity Sewer
Pipe In @ 9 O'Clock

Deposits: ☐ None ☐ Mud ☐ Sludge ☒ **Debris** ☐ Grease

Silt Depth: **0** (in.) Deposits Extent: **Medium**
